ESTIMATED AVAILABLE QUANTITIES OF COMMON BORROW (TYPE C) MATERIAL BY MILEPOST NORTHERN GLENN HIGHWAY - GUNSIGHT MOUNTAIN (MP 118.5) TO JUNCTION WITH RICHARDSON (MP 189) FALL 2013

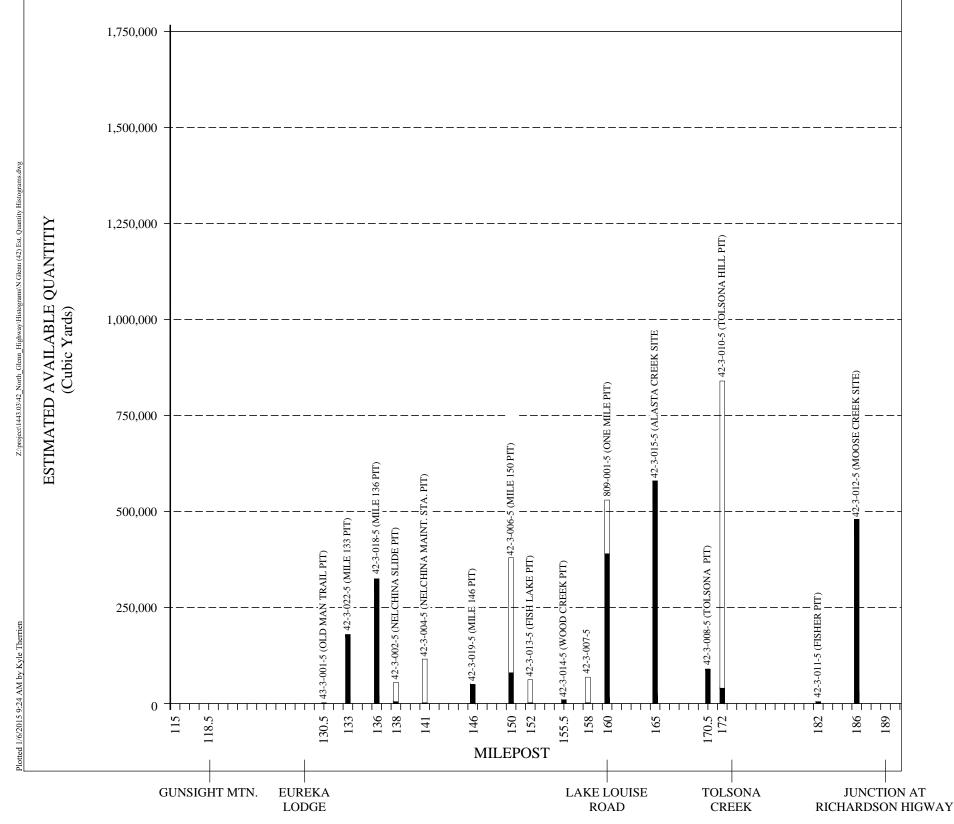
1. QUANTITIES WERE ESTIMATED BASED ON MATERIAL SITE INSPECTIONS CONDUCTED BY R&M CONSULTANTS, INC. IN AUGUST & SEPTEMBER 2013.

2. QUANTITIES OF AVAILABLE MATERIAL ARE "ROUGH" ESTIMATES BASED ON THE INFORMATION AVAILABLE AT THE TIME OF INSPECTION AND ARE PROVIDED FOR PLANNING PURPOSES ONLY. THEY SHOULD NOT BE USED FOR DESIGN OR CONSTRUCTION PURPOSES.
